**REFINEMENT OF PROMISING COATING COMPOSITIONS  
FOR DIRECTIONALLY CAST EUTECTICS**

**FINAL REPORT**

UNITED TECHNOLOGIES CORPORATION  
Pratt & Whitney Aircraft Group  
Commercial Products Division

NATIONAL AERONAUTICS AND SPACE ADMINISTRATION  
NASA-Lewis Research Center  
Contract NAS3-18920

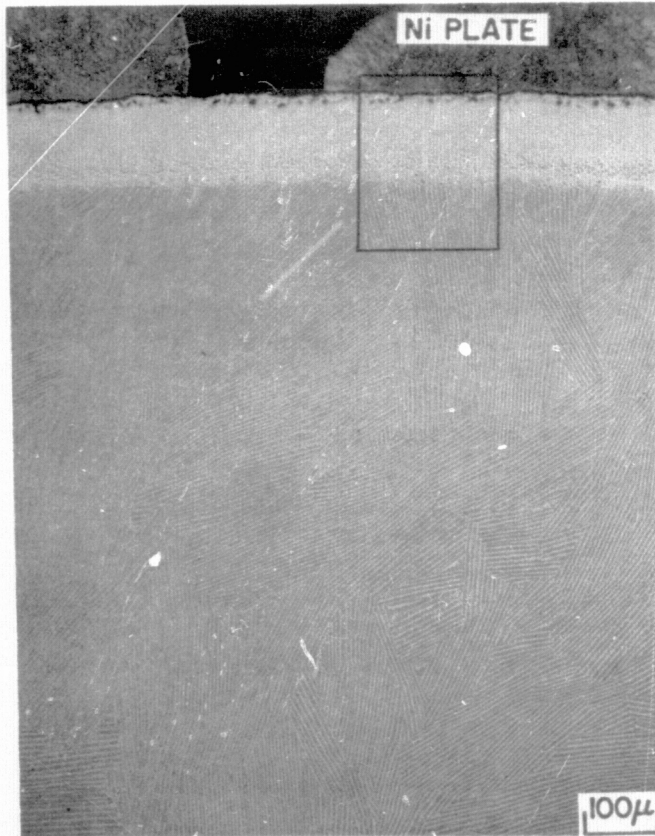
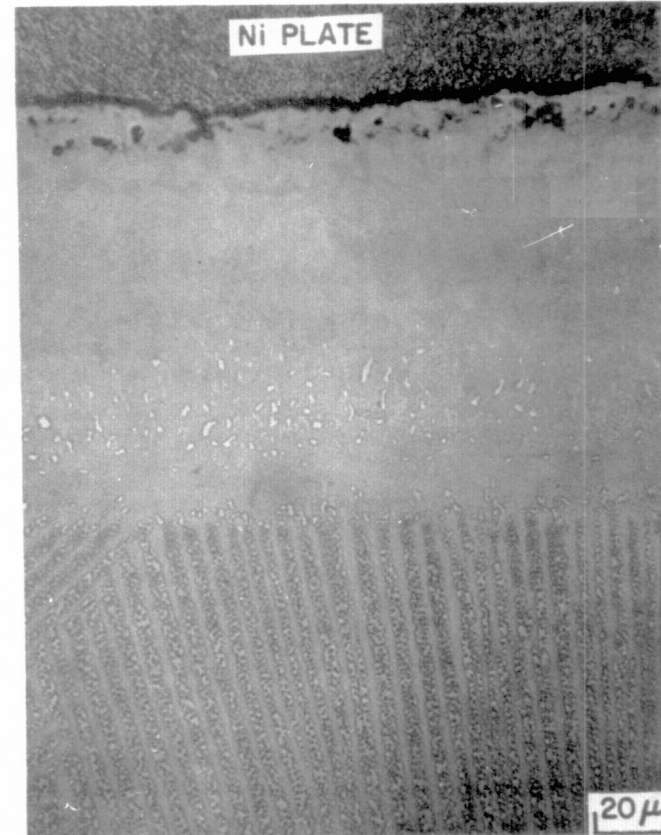
Figure 65 Microstructure of NiCrAlY + Pt Coated  $\gamma/\gamma'$  -  $\delta$  (6Cr) Specimen (E 290) which was Evaluated for 4486 Cycles in a Cycle I (700 to 1311 K;  $\Delta\epsilon_{TM} = 0.30\%$ ) Thermomechanical Fatigue Test.

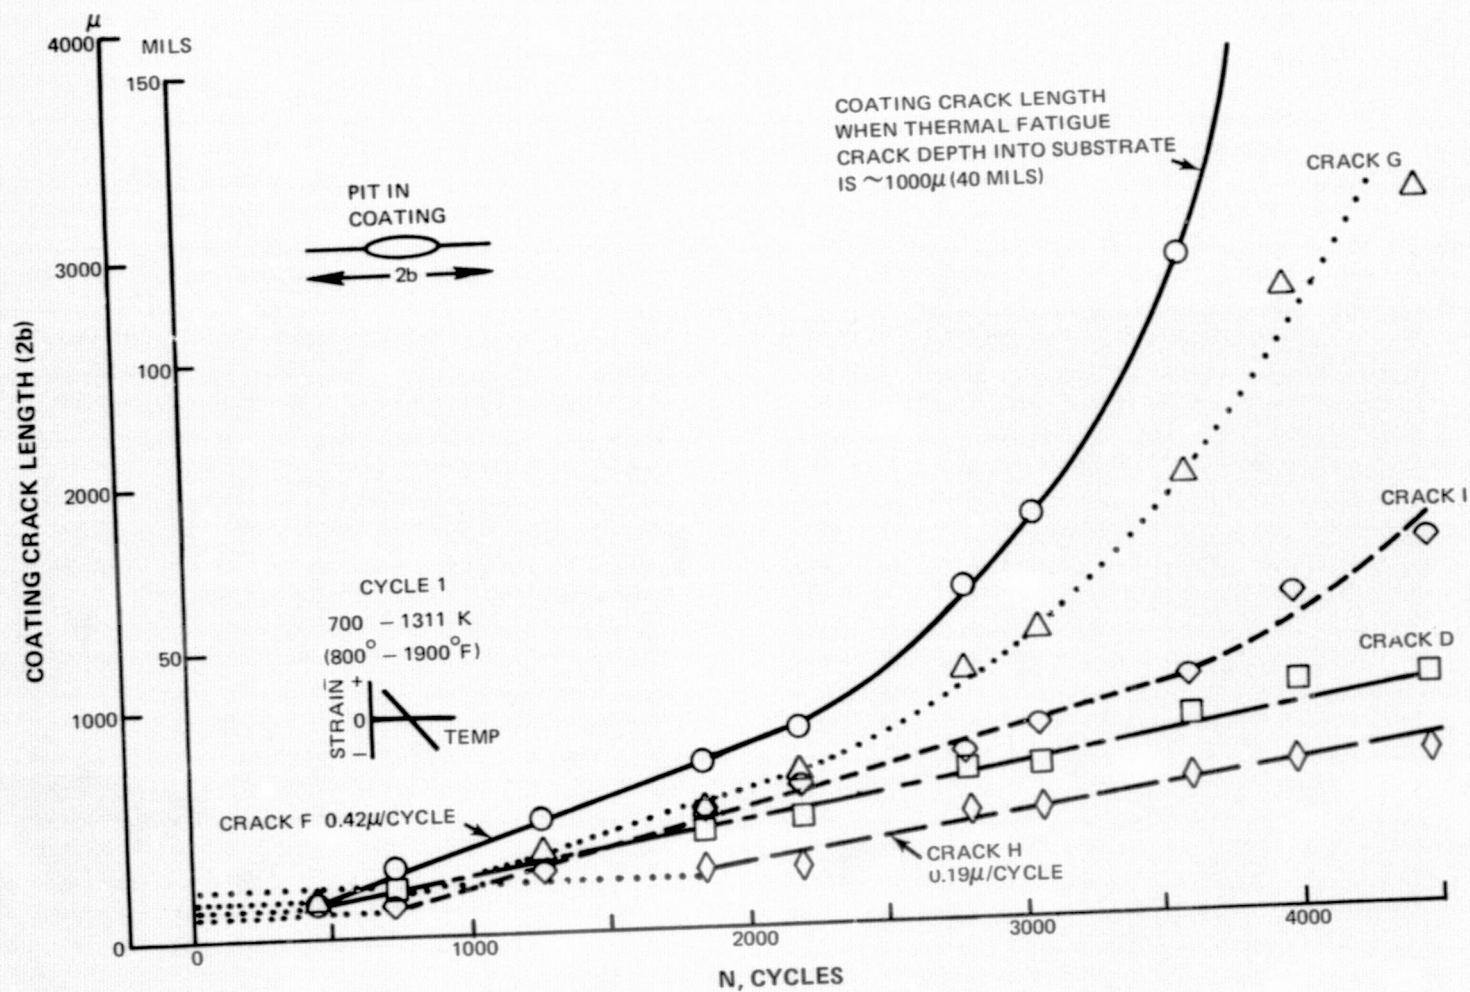
Figure 66 Surface Propagation of Thermal Fatigue Cracks in NiCrAlY + Pt Coated  $\gamma/\gamma'$  -  $\delta$  Specimen E 290 ( $\Delta\epsilon_{TM} = 0.30\%$ ).

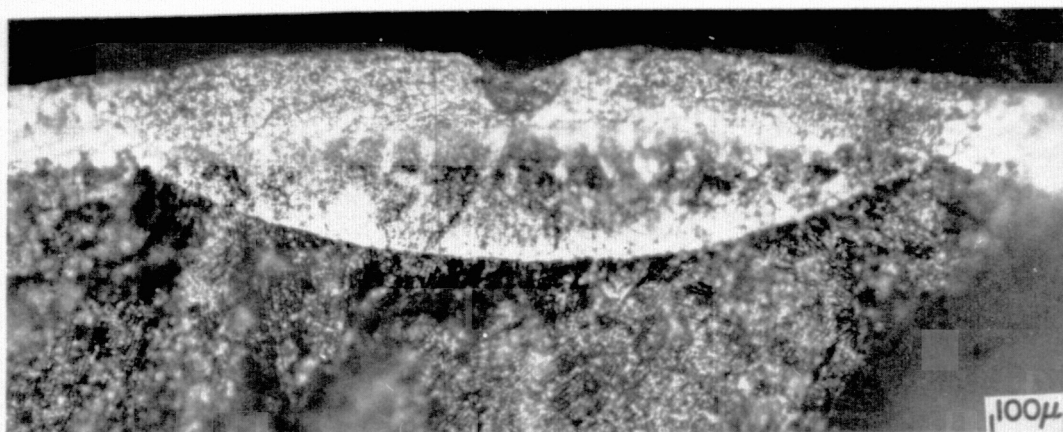
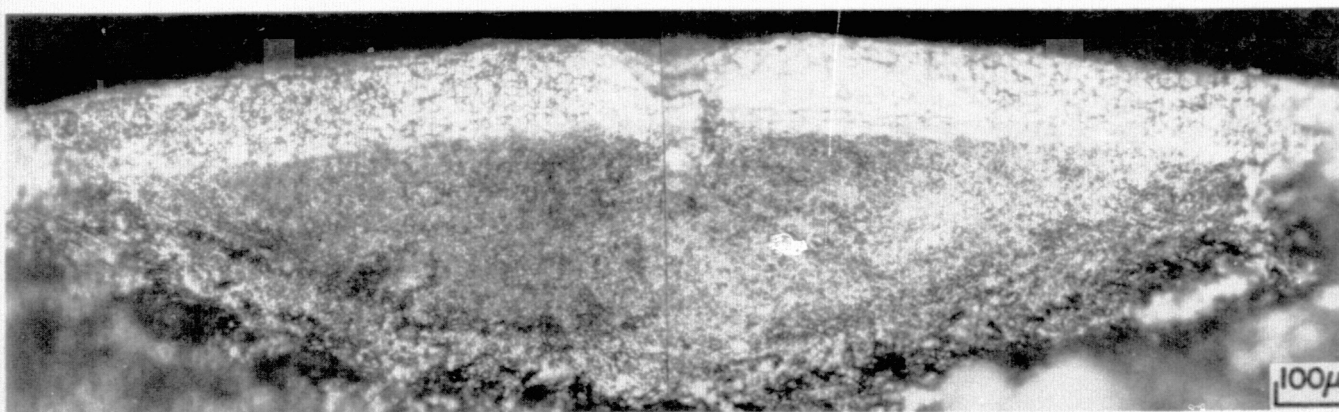
Figure 67    *Optical Fracture Surface Photographs of Secondary Thermal Fatigue Cracks D (top) and E (bottom) in NiCrAlY + Pt Coated  $\gamma/\gamma'$  -  $\delta$  Specimen (E 290) which was Evaluated for 4486 Cycles in a Cycle I (700 to 1311 K;  $\Delta\epsilon_{TM} = 0.30\%$ ) Thermomechanical Fatigue Test. Initiation of Both Coating Cracks was Detected After Approximately 450 Cycles.*  
(K-16737)

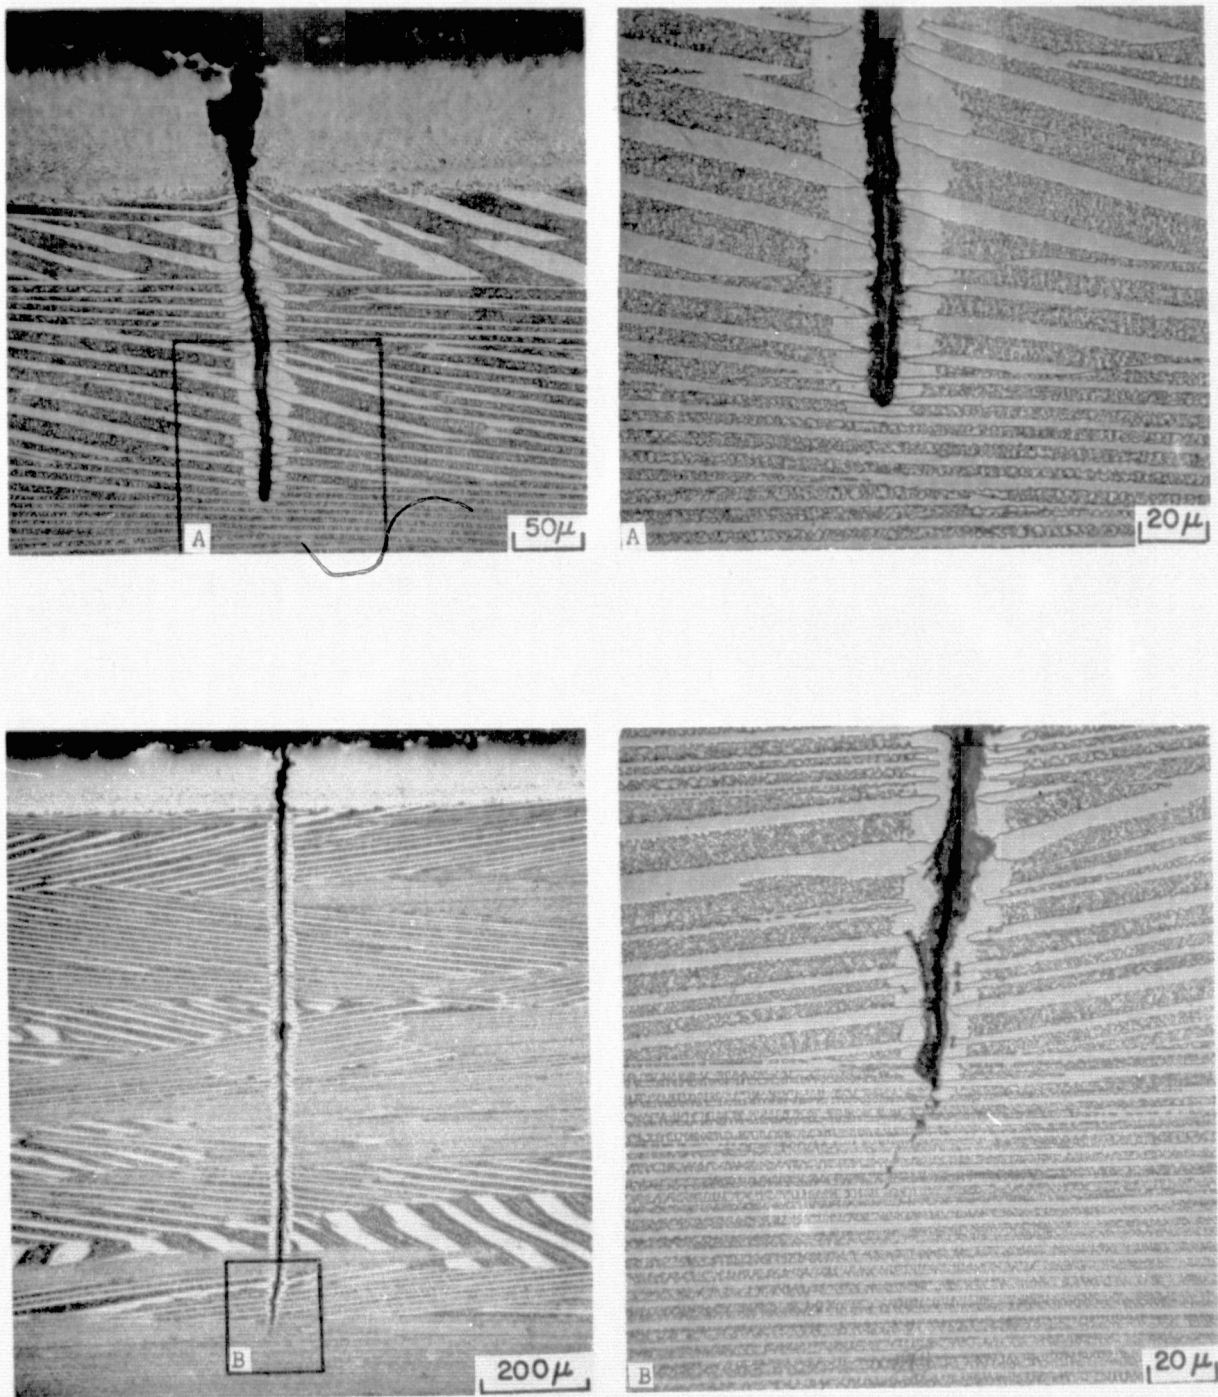
Figure 68 Microstructures of Pit Initiated Thermal Fatigue Cracks in NiCrAlY + Pt Coated  $\gamma/\gamma'$  -  $\delta$  (6Cr) Specimen (E 290) which was Evaluated for 4486 Cycles in a Cycle I (700 to 1311 K;  $\Delta\epsilon_{TM} = 0.30\%$ ) Thermomechanical Fatigue Test. An Oxidation Affected Zone Envelopes both Cracks. In Addition, for the Longer Crack (bottom), the  $\delta$  Phase has Started to Rupture Ahead of the Crack Tip. (K-16738)

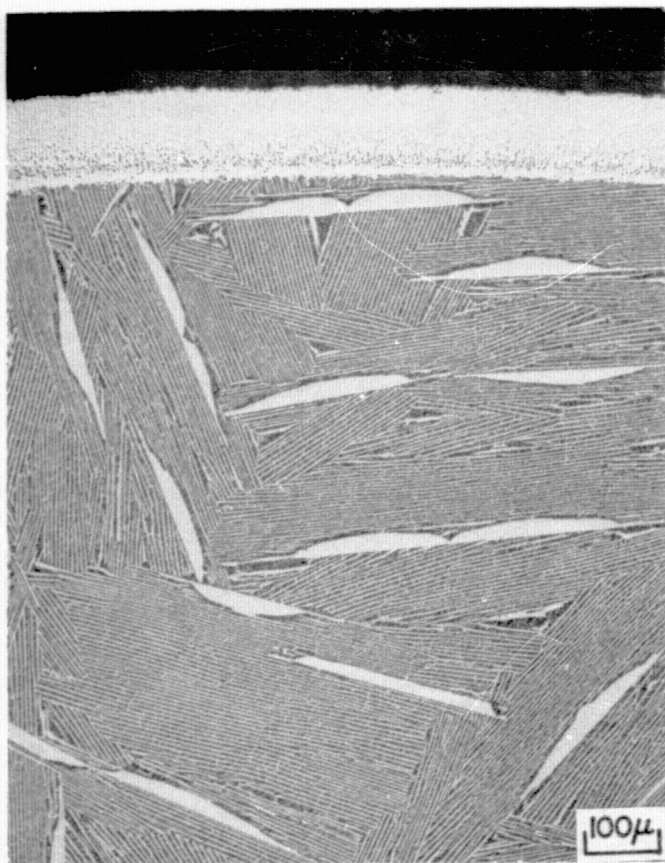
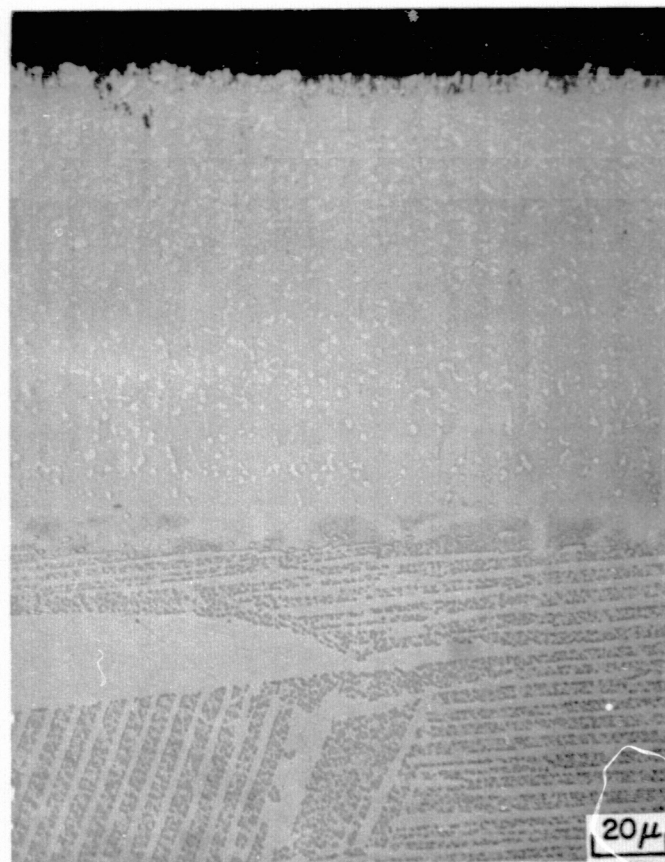
Figure 69 Microstructure of NiCrAlY + Pt Coated  $\gamma/\gamma' - \delta$  (6Cr) Specimen (E 488) which was Evaluated for 5270 Cycles in a Cycle I (755 to 1200 K;  $\Delta\epsilon_{TM} = 0.30\%$ ) Thermomechanical Fatigue Test.

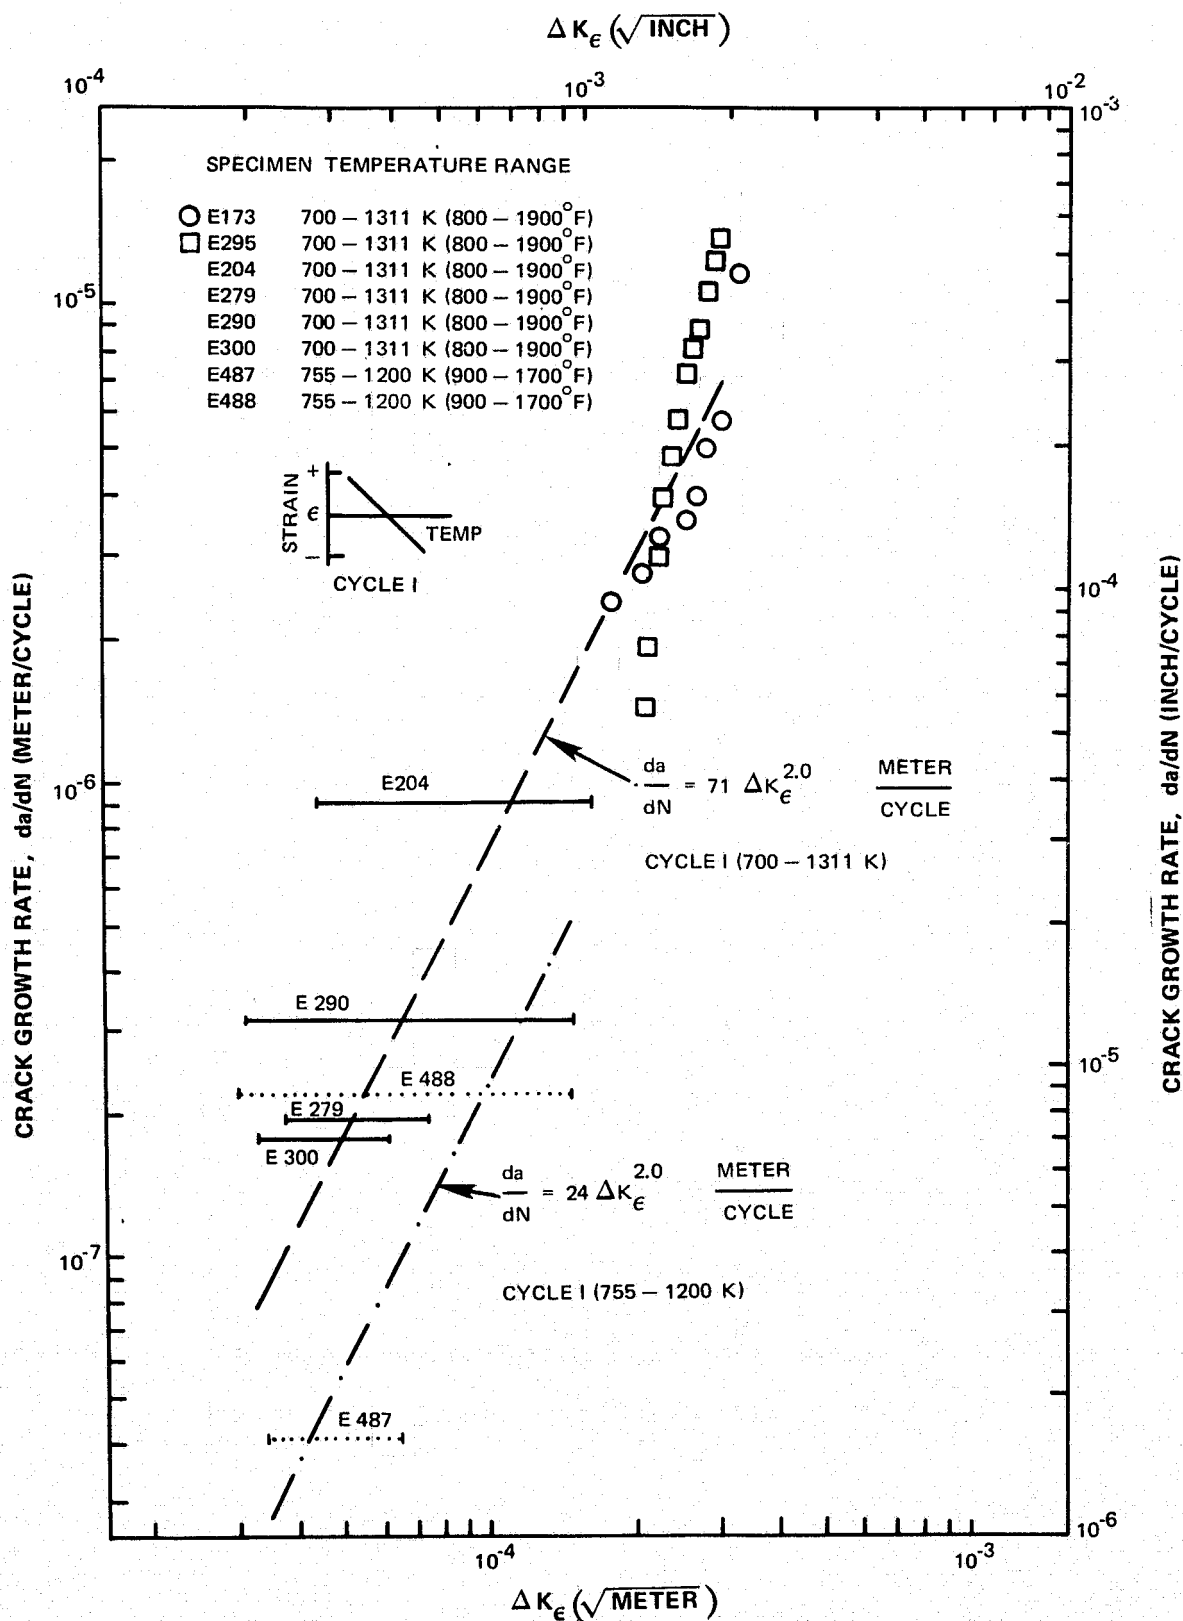
**Figure 70** Average Cycle I Thermomechanical Fatigue Crack Propagation Rates in  $\gamma/\gamma'$  -  $\delta$  Eutectic Superalloy Obtained with NiCrAlY (E 300, 487) and NiCrAlY + Pt (E 204, 279, 290, 488) Coated Specimens are Shown with Initial and Final Values of the Strain Intensity Factor Range,  $\Delta K_{\epsilon}$ . Data from Uncoated Specimens (E 173, 295) are Provided for Comparison.

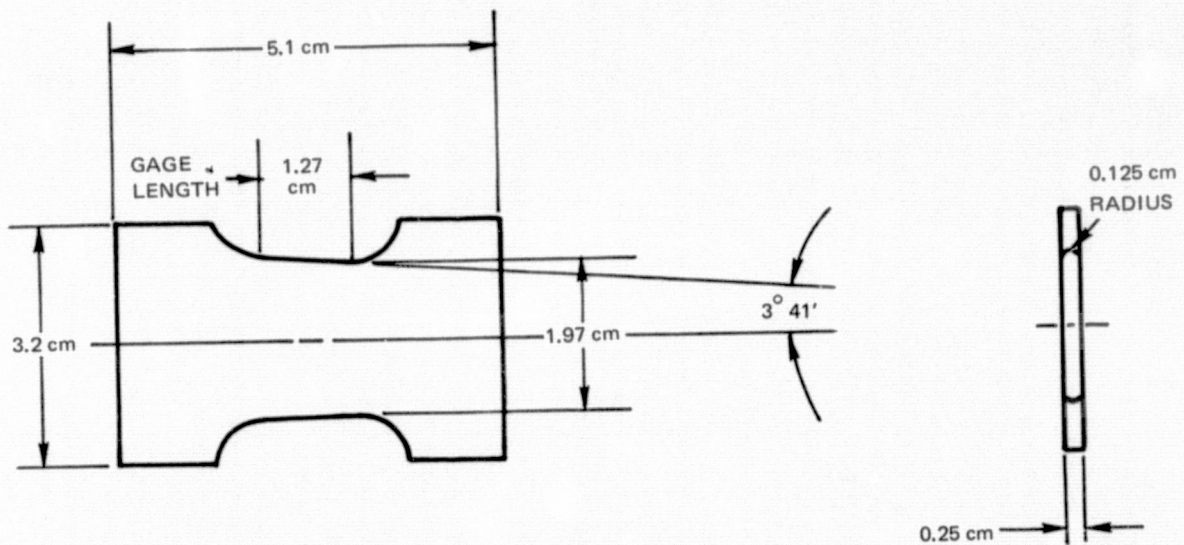
Figure 71 Isothermal Reversed Bending (Krouse) Fatigue Specimen.

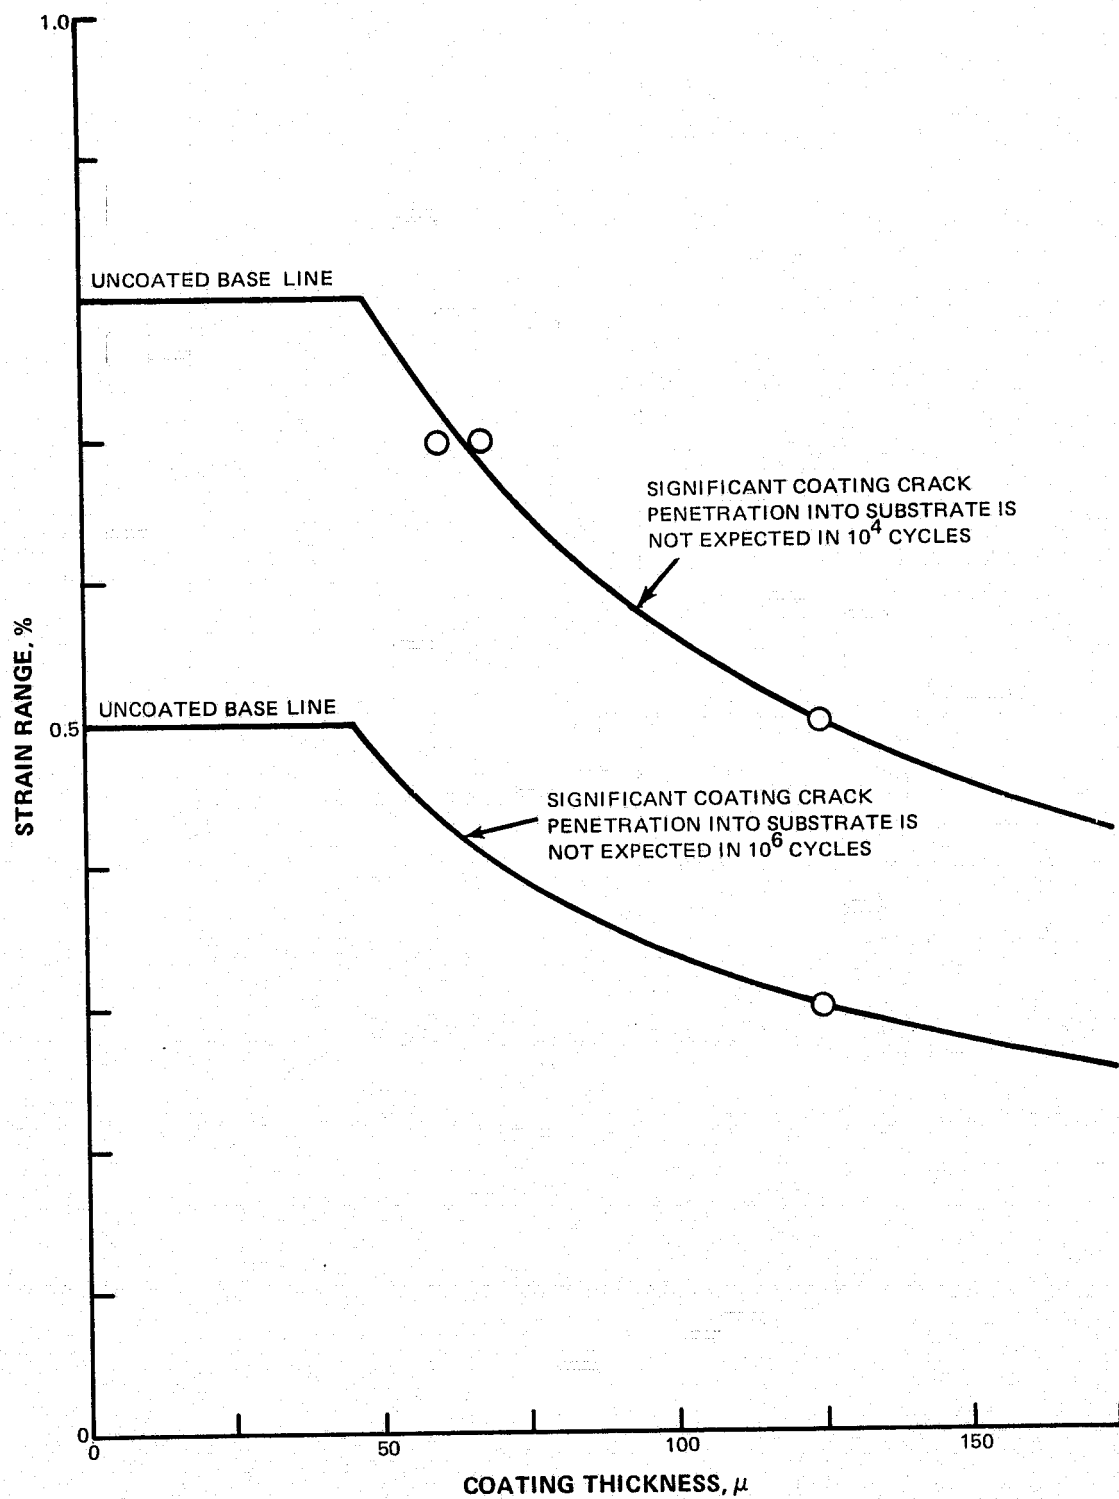
Figure 76 Estimated Effect of NiCrAlY Coating Thickness on 977 K (1300°F) Fatigue Strength of  $\gamma/\gamma' - \delta$  (6Cr) Alloy.

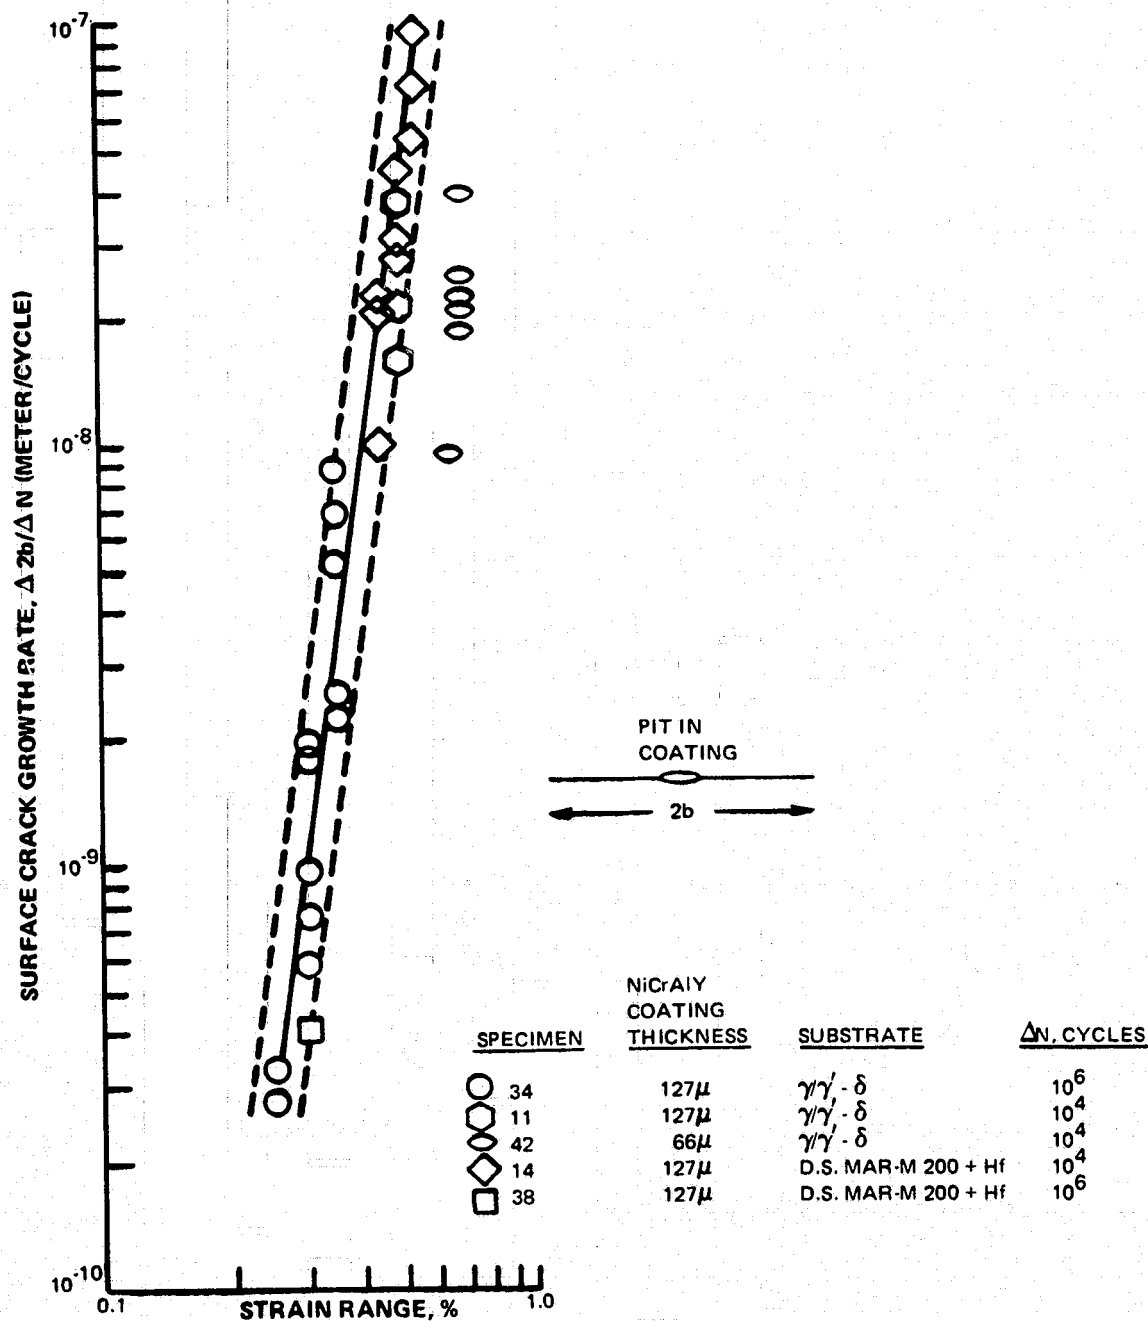
**Figure 77** Coating Crack Propagation Rate Versus Strain Range Data for Several Cracks in NiCrAlY Coated  $\gamma/\gamma' - \delta$  and D.S. MAR-M 200 + Hf Specimens Which Were Fatigue Tested at 977 K (1300°F). Note that the strain range required to achieve a given propagation rate is greater for the thinner coating.

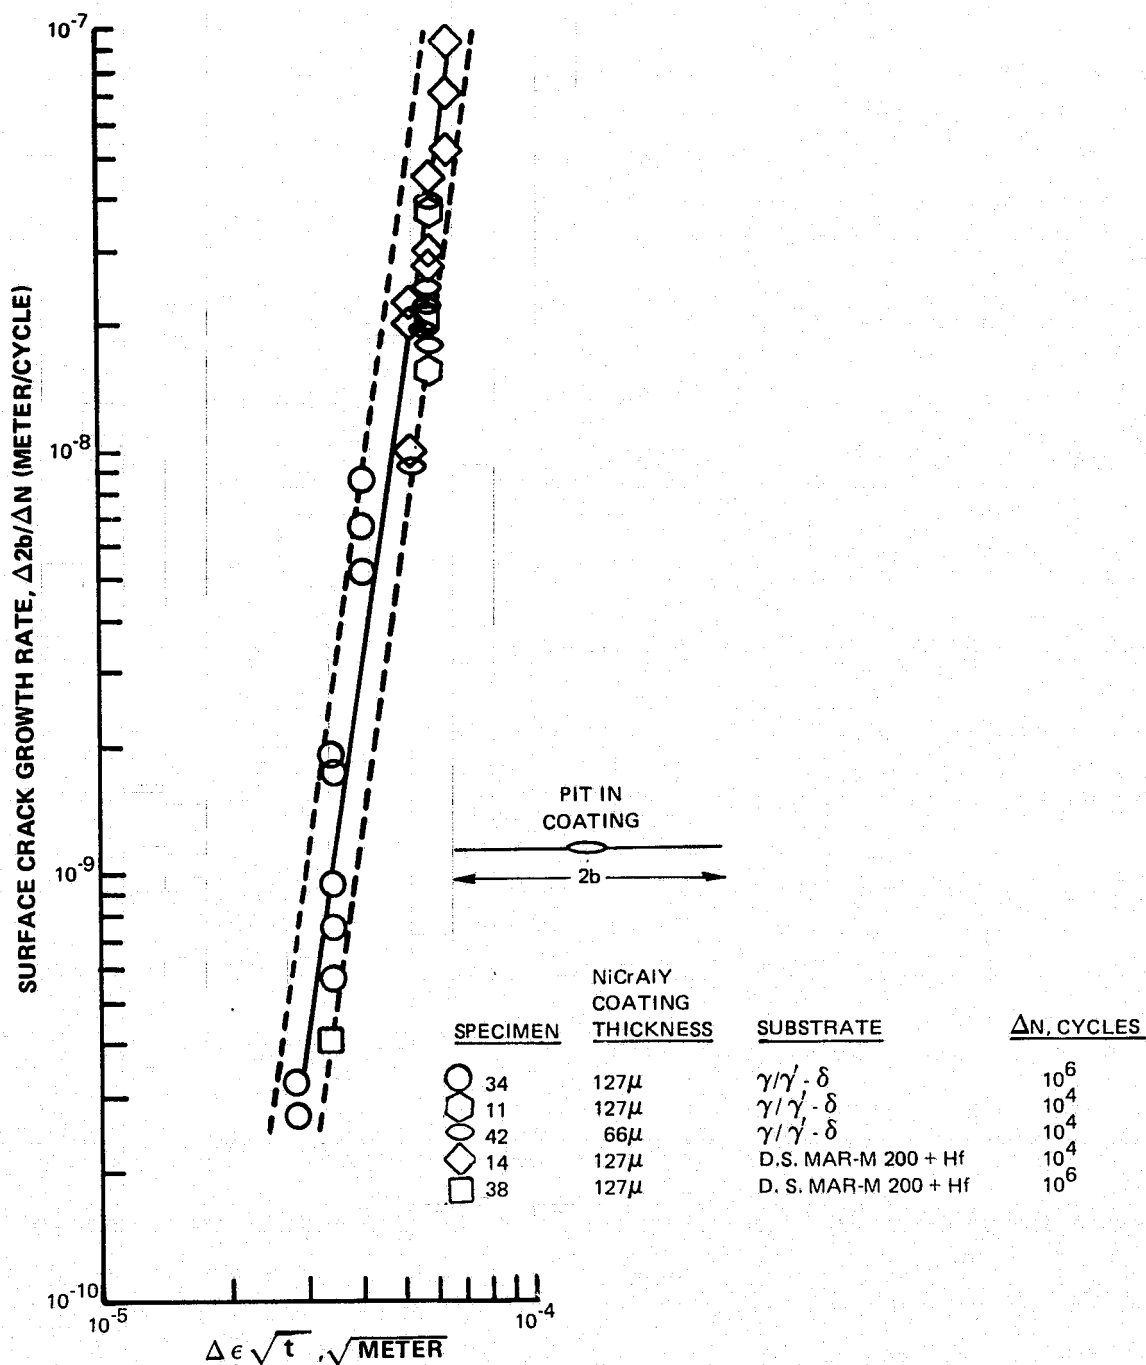
Figure 78 Coating Crack Propagation Rate Data as a Function of the Strain Range ( $\Delta\epsilon$ ) Times the Square Root of the Coating Thickness ( $\sqrt{t}$ ) for NiCrAlY Coated  $\gamma/\gamma' - \delta$  and D.S. MAR-M 200 + Hf Specimens Which Were Fatigue Tested at 977 K (1300°F).

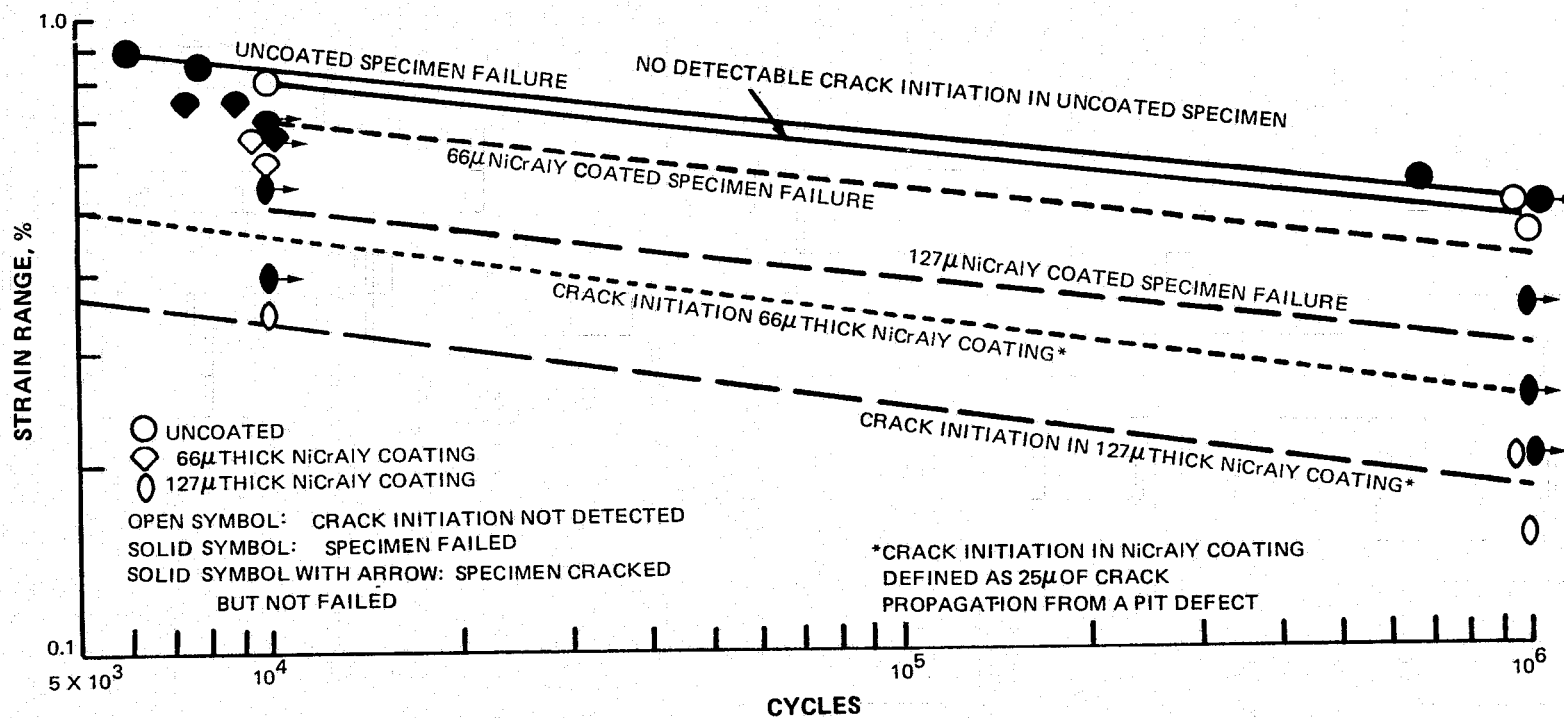
Figure 79 977 K (1300°F) Isothermal Fatigue Data for NiCrAlY Coated Longitudinal Grain Orientation  $\gamma/\gamma' - \delta$  (6Cr) Directionally Solidified Eutectic Alloy Systems.

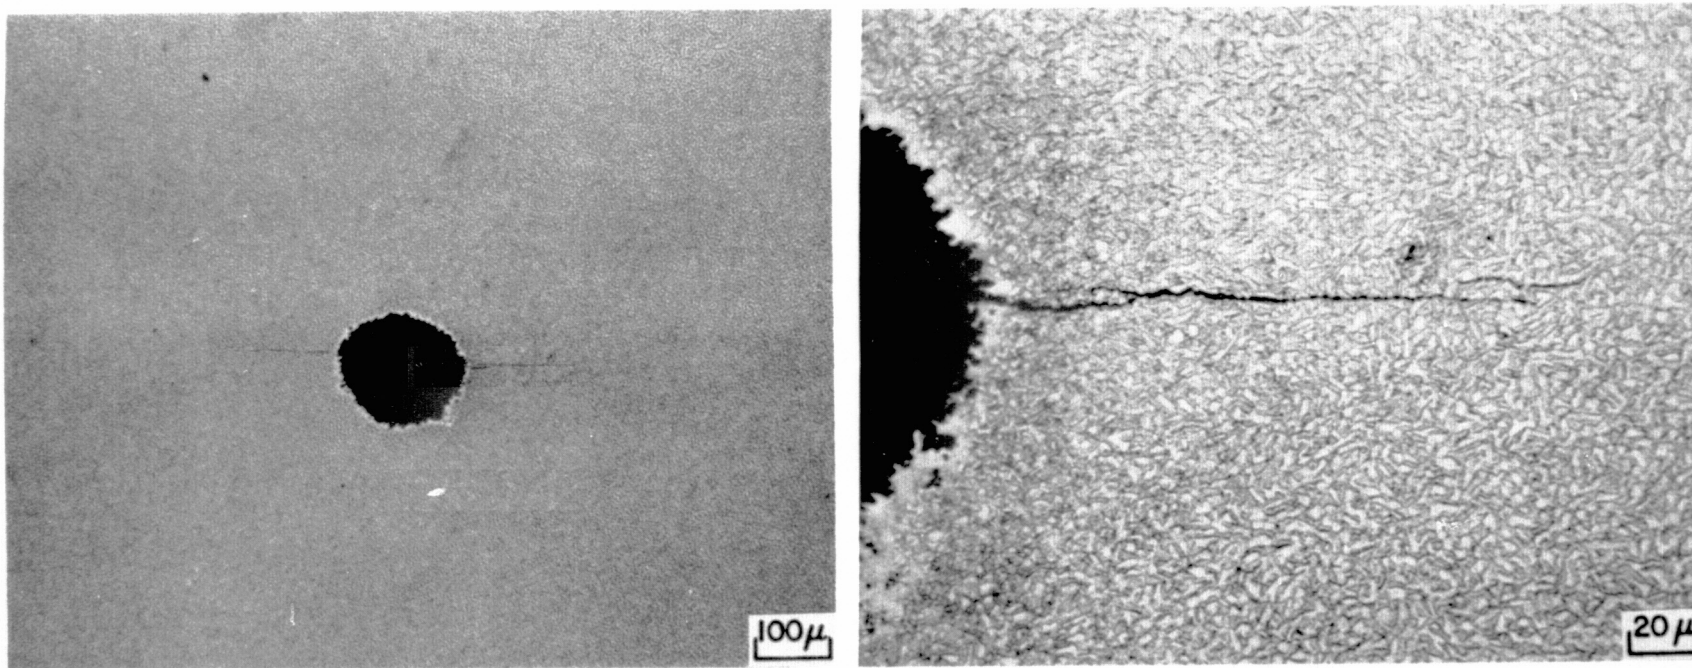
*Figure 80 Morphology of Pit Initiated Fatigue Crack in Plane of NiCrAlY Coating on  $\gamma/\gamma'$  -  $\delta$  Specimen (No.11) Which Was Evaluated in 977 K (1300°F) LCF Test. (K-17887)*

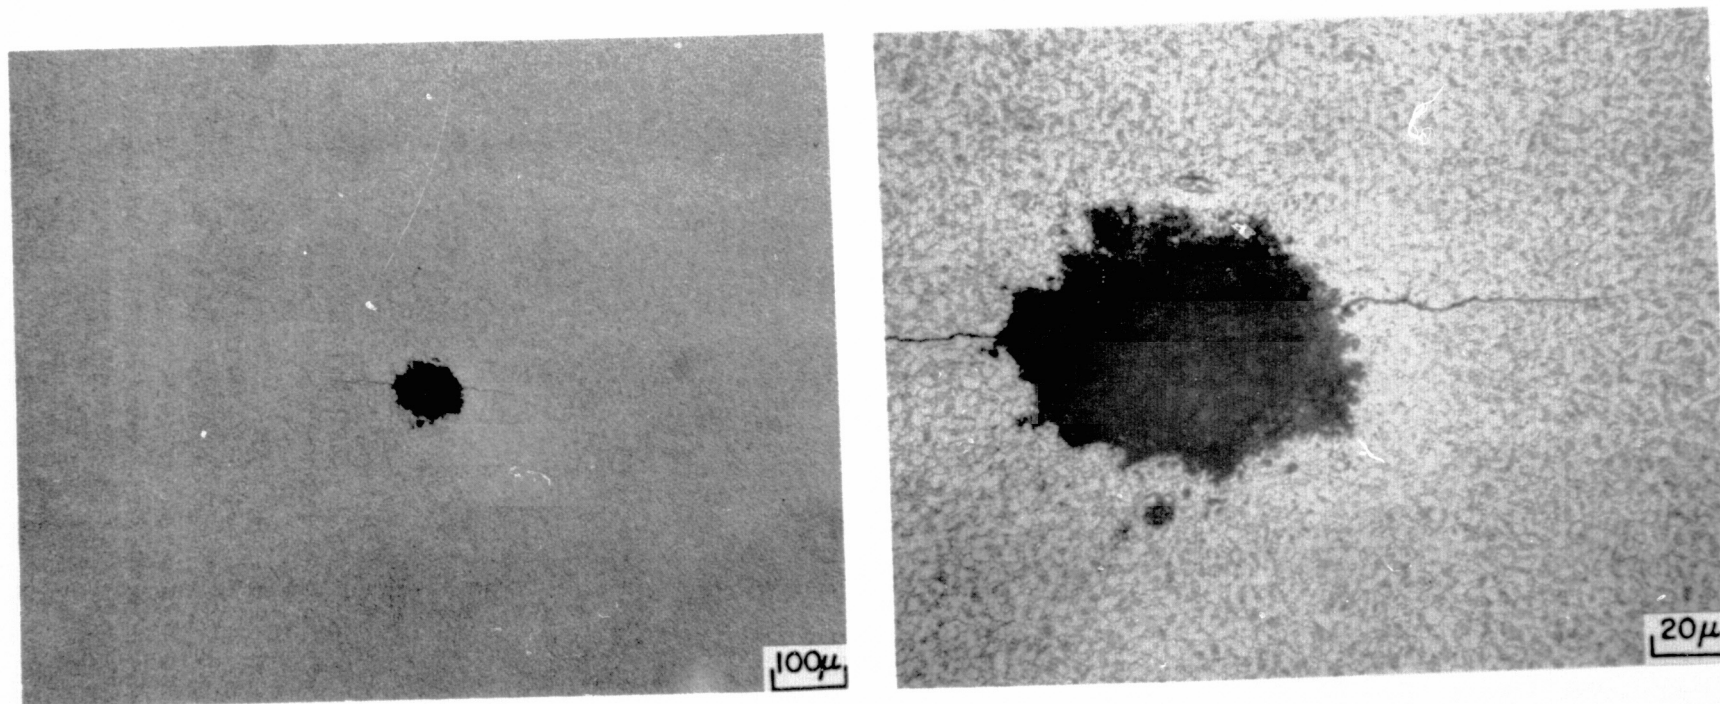
*Figure 81 Morphology of Pit Initiated Fatigue Crack in Plane of NiCrAlY Coating on D.S. MAR-M 200 + Hf Specimen (No. 15) Which Was Evaluated in 977 K (1300°F) LCF Test. (K-17888)*

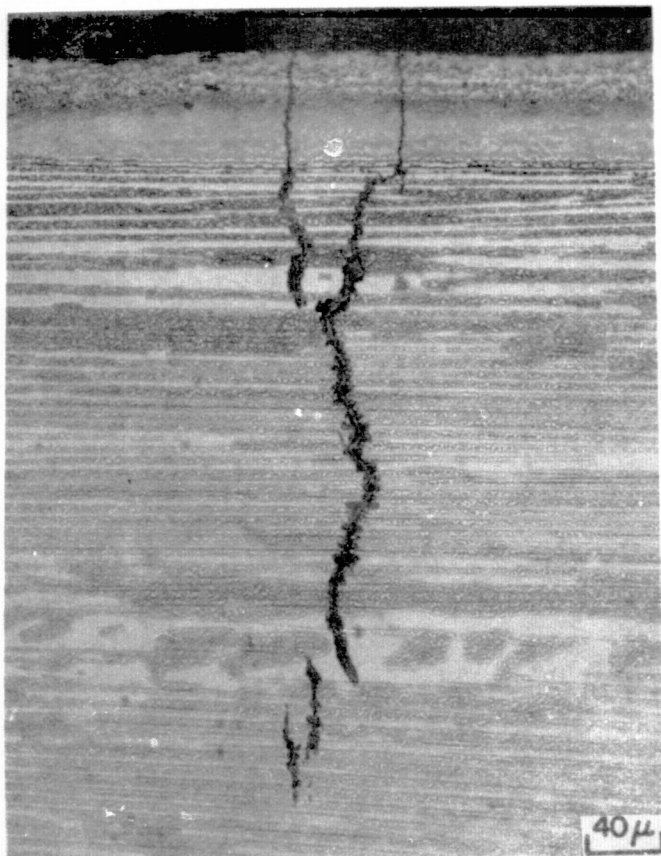
Pt + Al COATING  
LONGITUDINAL  $\gamma/\gamma'$ - $\delta$  SPECIMEN (NO. 30)  
FINAL STRAIN RANGE: 0.45%

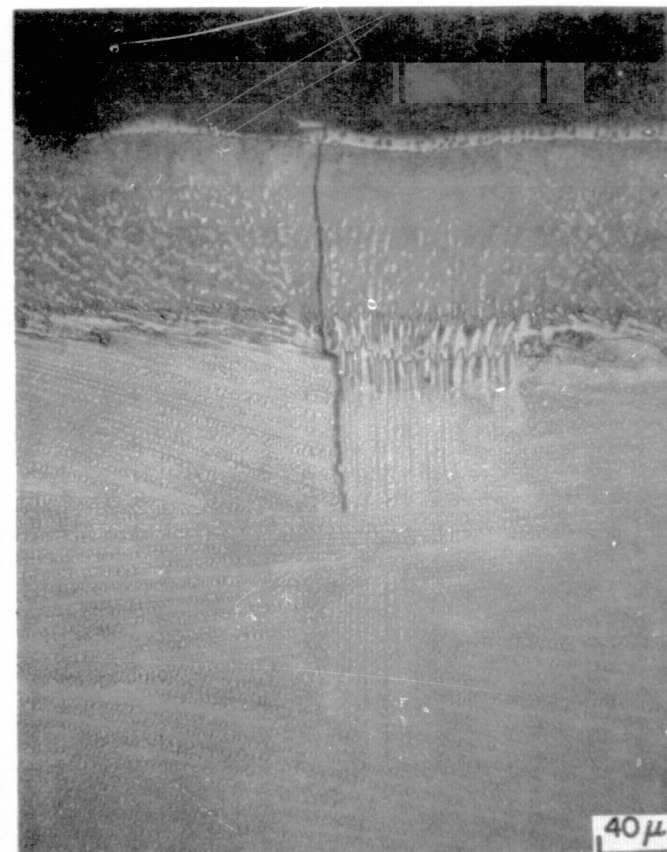
Pt + Al COATING  
TRANSVERSE  $\gamma/\gamma'$ - $\delta$  SPECIMEN (NO. 20)  
FINAL STRAIN RANGE: 0.30%
